OAKLAND COUNTY SHERIFF'S OFFICE TRAINING BULLETIN

June 28, 2022

Equipment Maintenance & Duty Ammunition

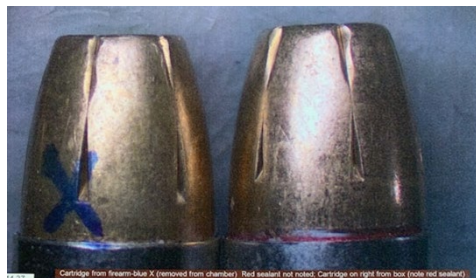
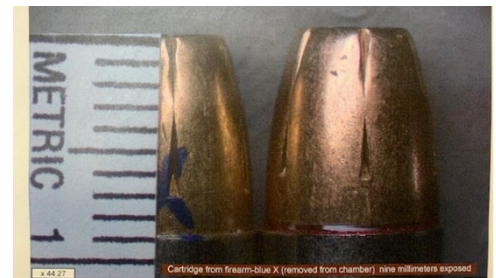
Although, all three of the possibilities are remote, they are still possible. Recently, range personnel were present when an issued duty round failed to fire. The duty round had what appeared to be a sufficient primer strike. Upon further inspection, it also appeared to have been chambered and unchambered multiple times.

The failed round was evaluated by the OCSO Crime Lab. It was determined that there were at least two clear ejector marks on the casing, the bullet itself had been pushed farther into the casing, and there was additional wear on the casing. All of which are indicative of being unchambering multiple times, and cause for the failure to fire.

The Sheriff's Office Training Unit continues to stress that chambered duty rounds are not to be reused or rechambered in any weapon carried while on duty. Range staff will continue to require leaving the chambered duty round in the weapon and firing it as part of the required course, regardless of the course, or ammunition requirement for that course. This procedure ensures that the duty round is not damaged, avoiding the possibility of the round failing to fire or eject.
